TREC Technical Report 60-54

YHC-1B U. S. ARMY "CHINOOK" MOCKUP EVALUATION
Morton, Pennsylvania
27 January 1960

REPORT OF CRASH INJURY EVALUATION
AvCIR-13-PV-118
September 1960

VERTOL YHC-1B U. S. ARMY "CHINOOK"

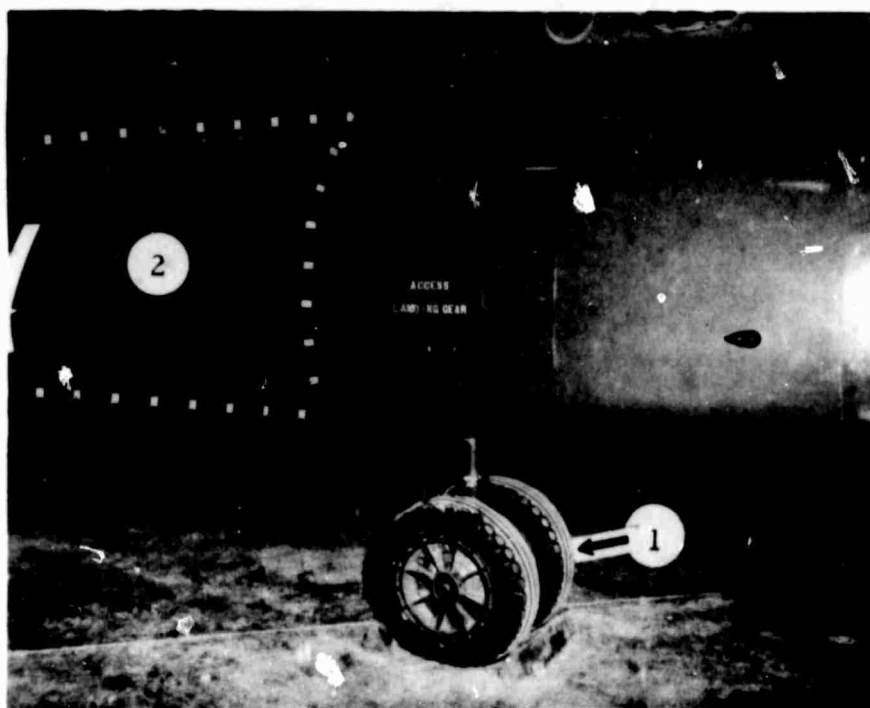
Figure 5. Main landing gear (right) (1); fuel cell area in pod (2).

Careful attention was given to the location of the main landing gear as shown in Figures 2, 5, and 6. The proximity of this landing gear to the fuel cells creates a potential post-crash fire hazard. Even though impact-resistant fuel cells are to be utilized in this aircraft, it would seem desirable not to expose the fuel cells to more rupture-producing structure than necessary. Accident experience in Army aviation reveals that the majority of the fatalities are the result of post-crash fires, many of which result from hard landings or relatively low magnitude impacts in which the fuel cells were ruptured.

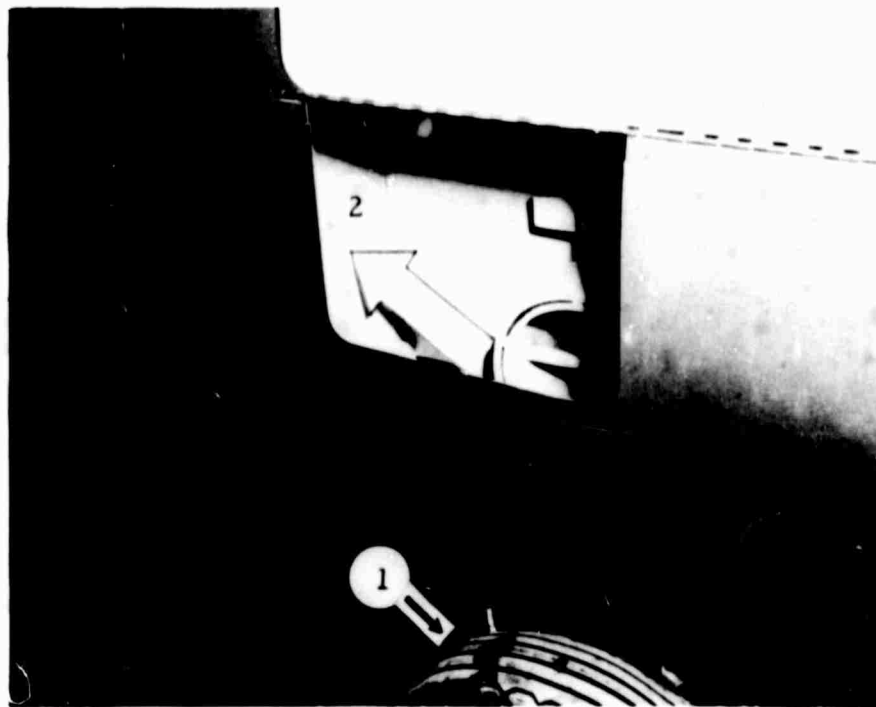
Figure 6. Landing gear (1); fuel cell forward end (2).

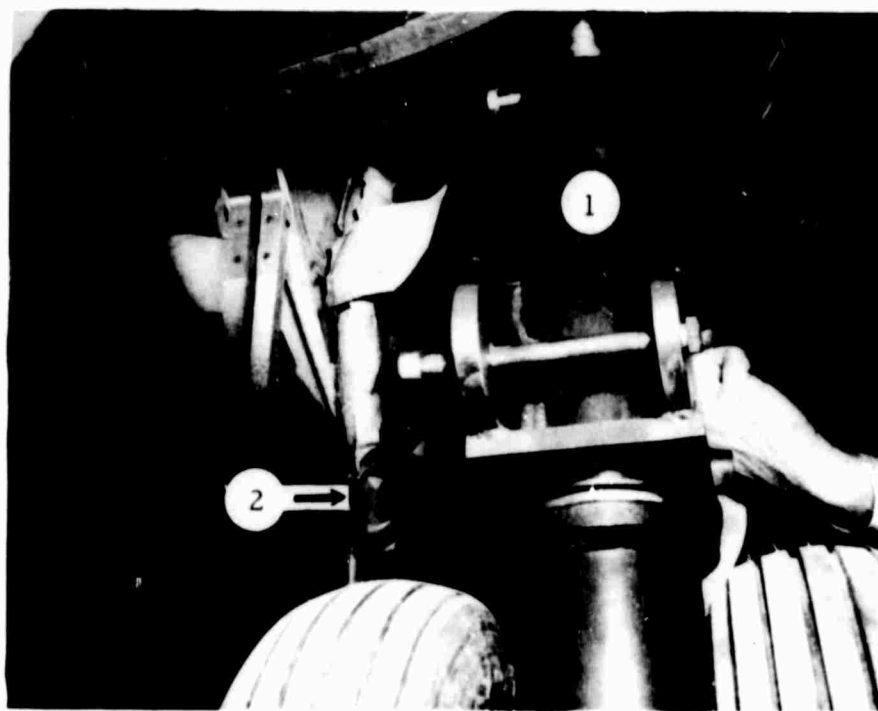
Note in Figure 10 that the pressure fuel line passes between the fuselage wall and the rear landing gear as it enters the fuselage with very little clearance. Any inward displacement of the aft landing gear during a hard landing or during a crash can easily rupture this fuel line. The line should be routed away from the aft landing gear to eliminate a potential source of fuel line rupture and subsequent post-crash fire.

Figure 10. Aft landing gear (1); pressure fuel line (2).

1. A thorough analysis and necessary dynamic tests be conducted to ascertain whether the forward and rear transmissions and rotor support assemblies are adequate to prevent displacement of these units into occupied areas under survivable crash conditions.
2. Consideration be given to dynamic testing of the main landing gear, pod, and fuel cell arrangement to determine the capability of the fuel cells to resist rupture under survivable crash force conditions.
3. The support structure for the turbine engines be so designed as to allow the engines to break loose and be thrown clear of the aircraft during a crash.
4. The pressure fuel lines be routed away from the aft landing gear to eliminate a potentially serious fire hazard.

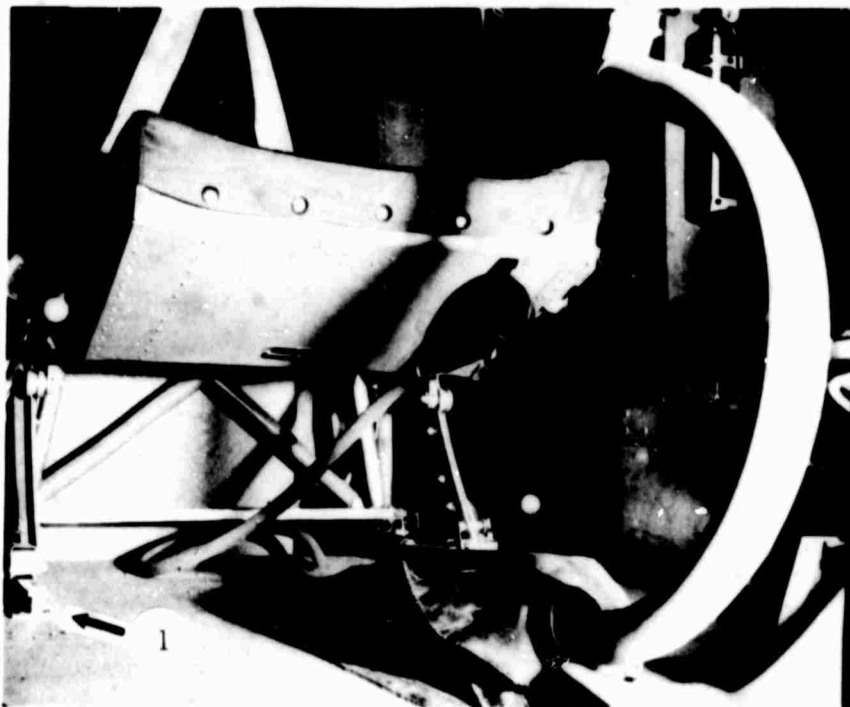
The seats are mounted on seat tracks, as indicated in Figure 17. Examination of the seat tracks revealed no forward stop. It appears that the seats can slide completely off the track in the event of jamming or failure of the manual control stops. Positive stops at the forward end of the tracks should be provided.

Figure 17. Pilot's seat, underside. Seat track (1).

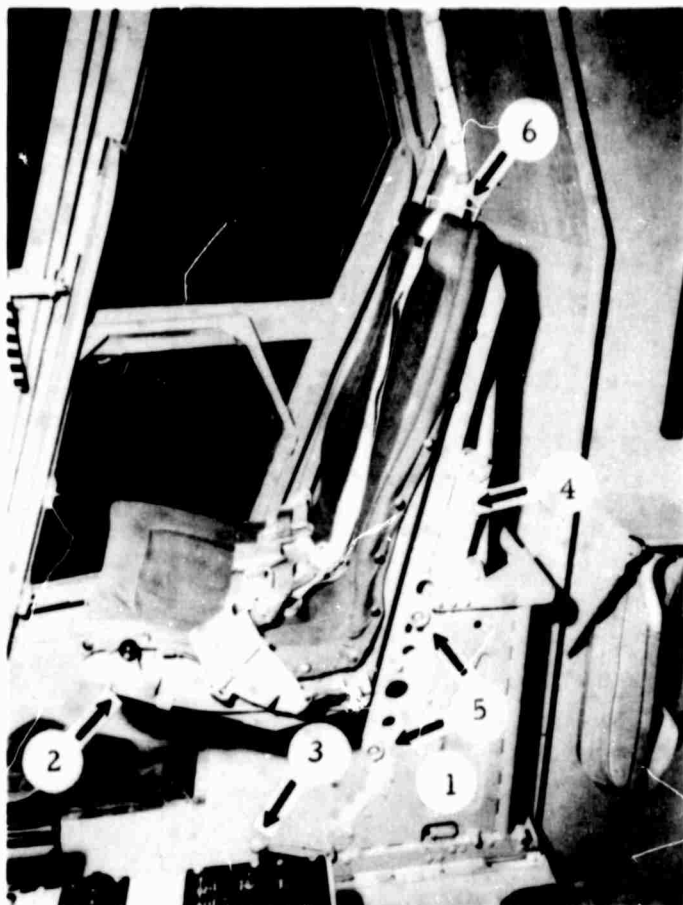
Figure 19 shows also the safety belt and shoulder harness installation. The seat belt anchorage is located at the lower left corner of the seat pan. The anchorage allows the belt to move inward or outward against the side of the seat pan and to rotate fore and aft in an arc. This form of self-alignment is a desirable feature, preventing anchorage failure due to prying action under side-load conditions.

The shoulder harnesses are attached to inertia reels mounted on the seat backs. Such an arrangement results in impact loading being added to the seat, which tends to overload the seat and cause failure of the seat supporting structure. If the seat does fail, the occupant

Figure 19. Pilot seat (1) showing supporting structure, safety belt, and shoulder harness installation. Inertia reel manual control (2); fore/aft seat adjustment control handle (3); vertical seat adjustment slide rail (4); seat tilt adjustment rollers (5); eight-inch-wide shoulder harness guide (6) on back of seat top.

restraint system (seat belt and shoulder harness) becomes ineffective and permits the occupant (restrained in his seat) to be thrown in the direction of the crash force. This has been the cause of dangerous and fatal injuries in a number of helicopter accidents. Based upon the foregoing, the inertia reels should be attached to basic aircraft structure to prevent overloading of the seat during crash force decelerations and to provide occupant restraint in event of seat failure.

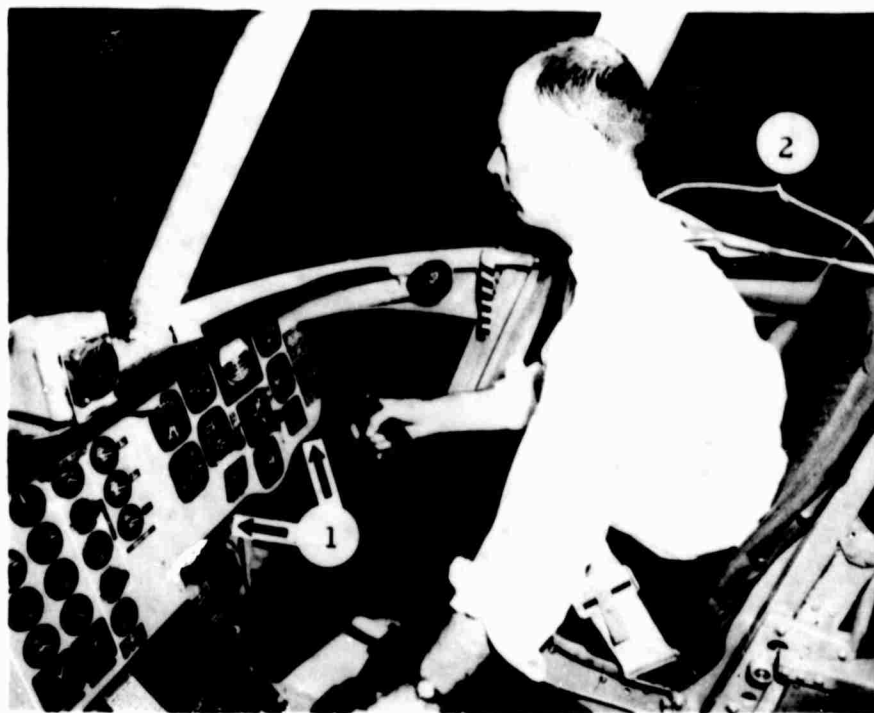
During the evaluation, it also was noted that the pilot was required to lean slightly forward in his seat in order to reach the controls comfortably, as illustrated in Figure 20. This position requires that the shoulder harness be extended over the seat back a distance of 15 to 18 inches. In the event the pilot (or copilot) is thrown sideways, the extension of the shoulder harness coupled with the unusually wide harness guide (shown in Figure 19) will permit him to strike the door frame and door jettison handle, as illustrated in Figures 21 and 22.

Figure 20. Pilot in normal seated position restrained by safety belt and shoulder harness. Lower edge of instrument panel (1); extended shoulder harness (2).

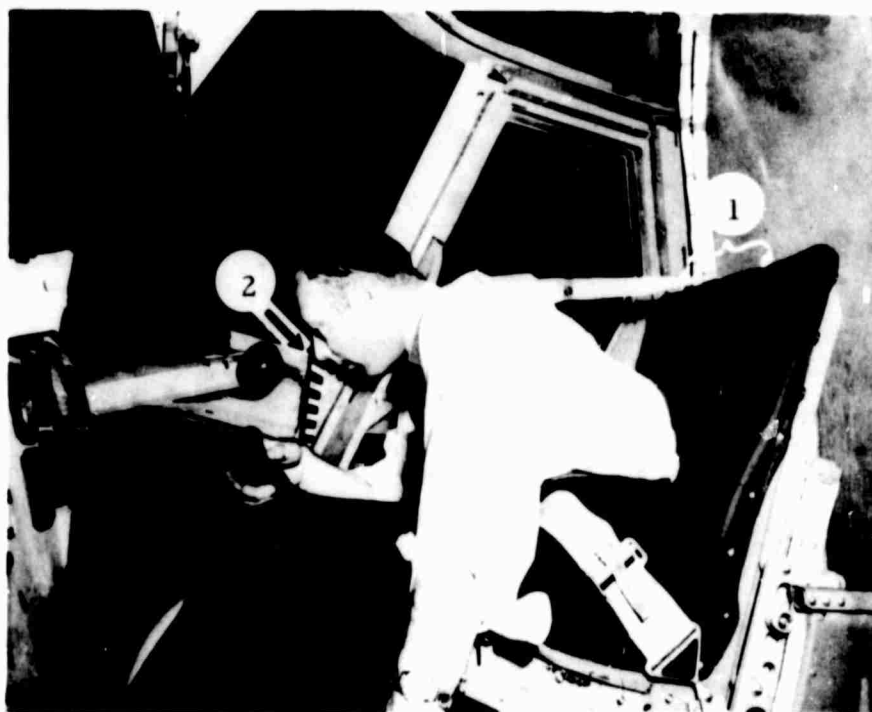
Figure 21. Extent of lateral displacement of shoulder harness due to wide guide (1) allows pilot to strike jettisonable door frame and handle (2).

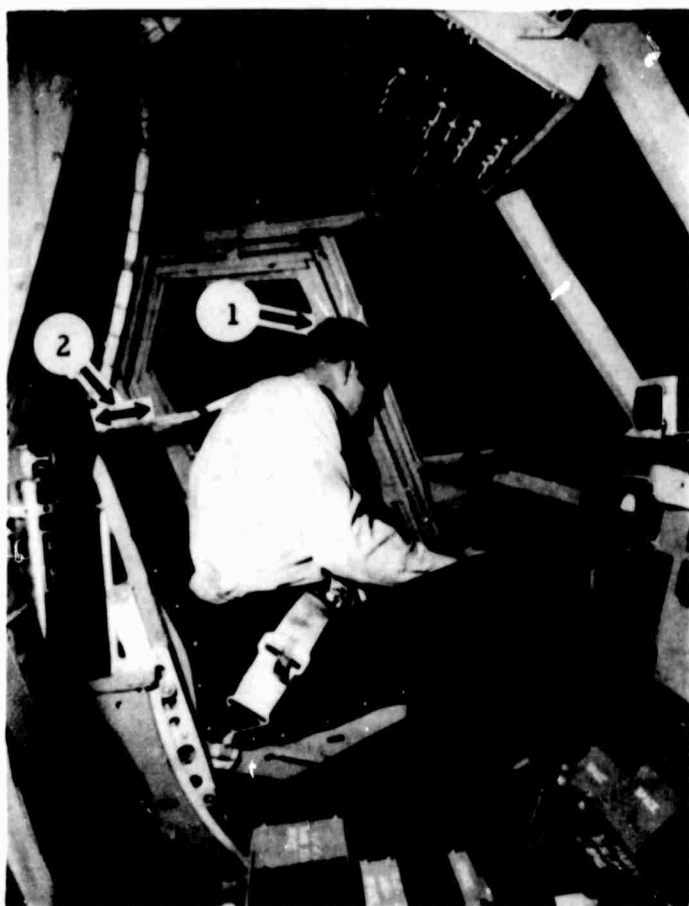
Figure 22. Copilot being thrown sideways, head against jettisonable door frame (1); lateral displacement of shoulder harness (2) to the left due to the width of the shoulder harness guide.

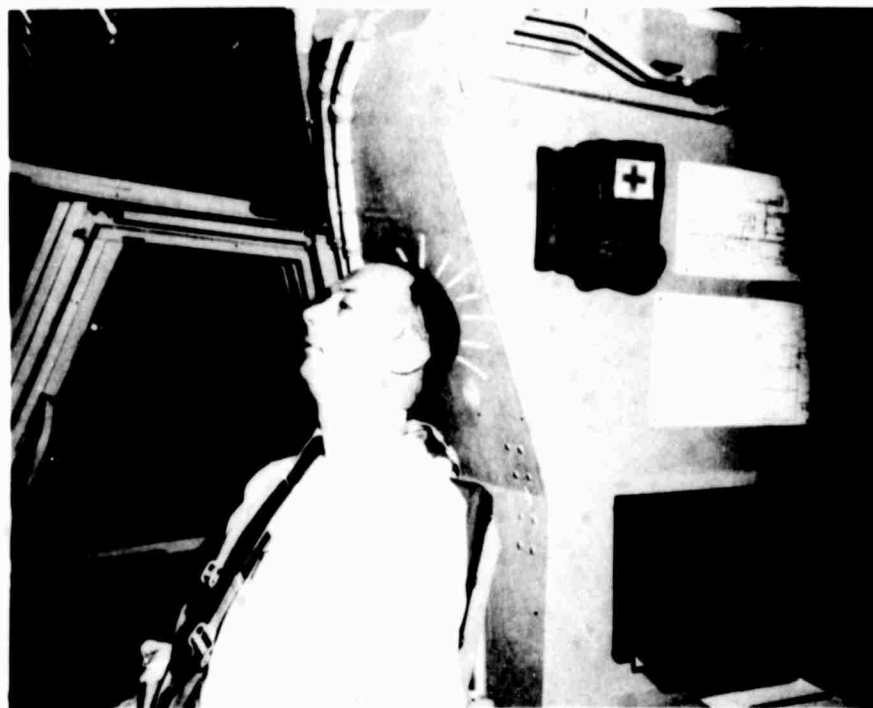
Figures 23 and 24 illustrate the manner in which both the pilot and copilot can be injured by striking their heads against the aft bulkhead by rebound during longitudinal decelerations. The bulkheads behind the pilot and copilot seats should be padded with high energy absorption material.

Figure 23. Pilot's head striking aft bulkhead.

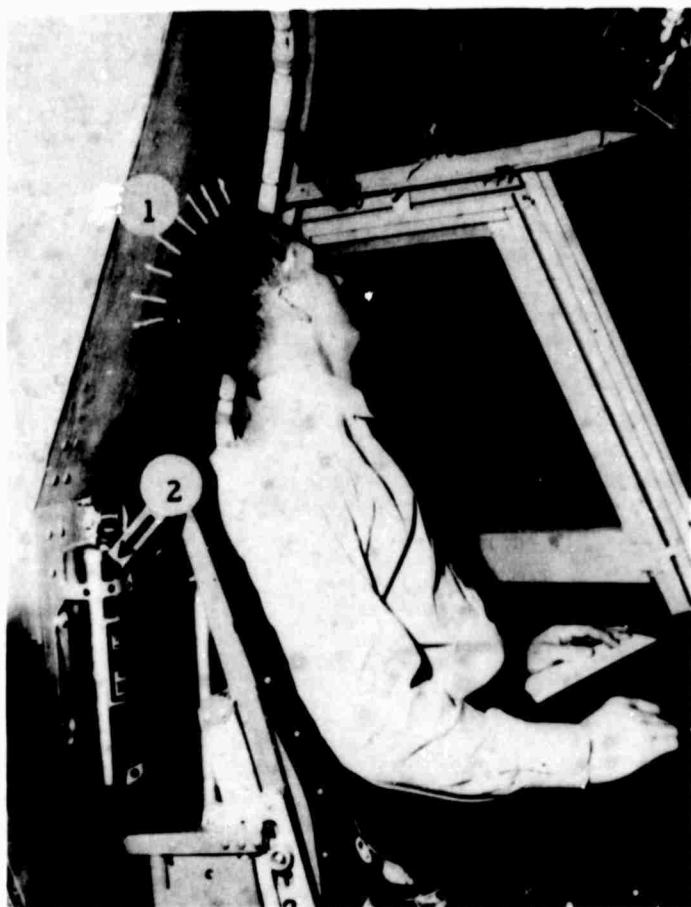
Figure 24. Copilot striking head against aft bulkhead (1); fire extinguisher location (2).

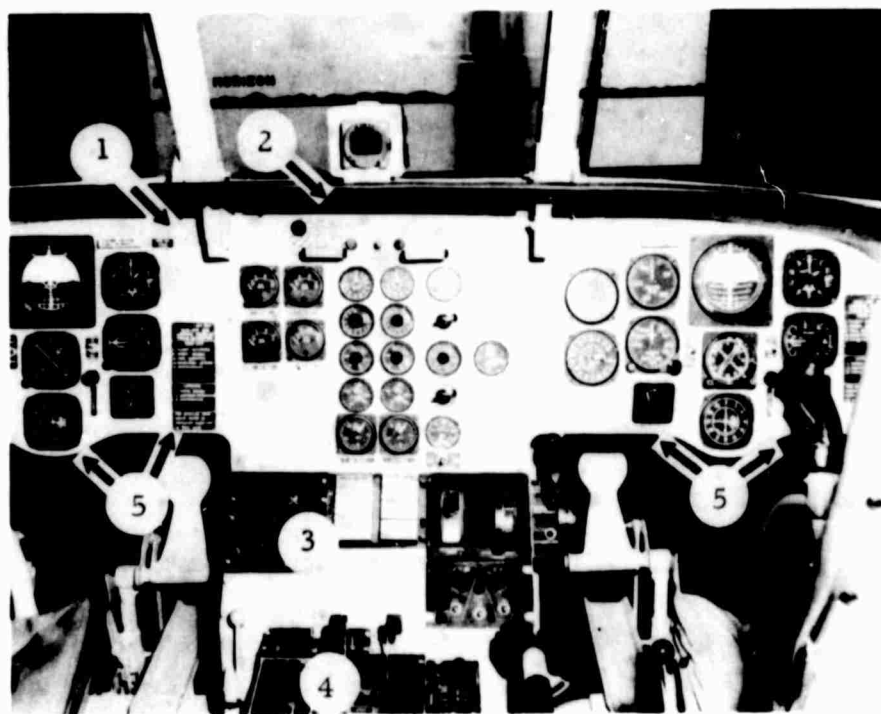
Figure 25. Instrument panel (1); glare shield (2); control pedestal (3); console (4); sharp edge lower instrument panel (5).

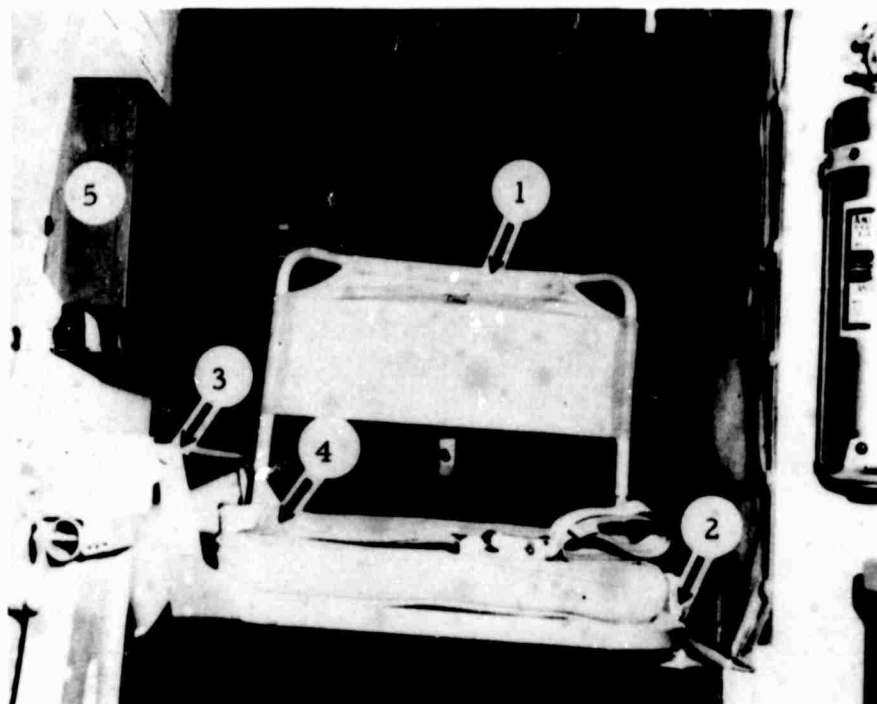
In the flight position (Figure 27) the occupant is restrained only by a seat belt. The lack of upper torso restraint will permit the occupant to be thrown against various items in his immediate environment during a crash, as illustrated in Figures 28, 29, and 30. The low seat back also could cause a serious back injury in the event this crew chief rebounded during a forward deceleration. This seating arrangement should be carefully studied and every effort made to provide the occupant protection at least equal to that of the pilot and copilot. A higher seat back, some sort of upper torso restraint, and padding of those surfaces within striking range of his head would provide such protection.

Figure 27. Crew chief/troop commander seat in flight position (looking aft). Seat back (1); seat pan snap lock (2); forward hinge point (3); safety belt (4); map case (5).

12. The crew chief/troop commander's seat and supporting structures be tested dynamically to determine their ability to withstand survivable crash force conditions. (This seat should be subjected to and able to withstand the same G loads as the pilot's and copilot's seats.)

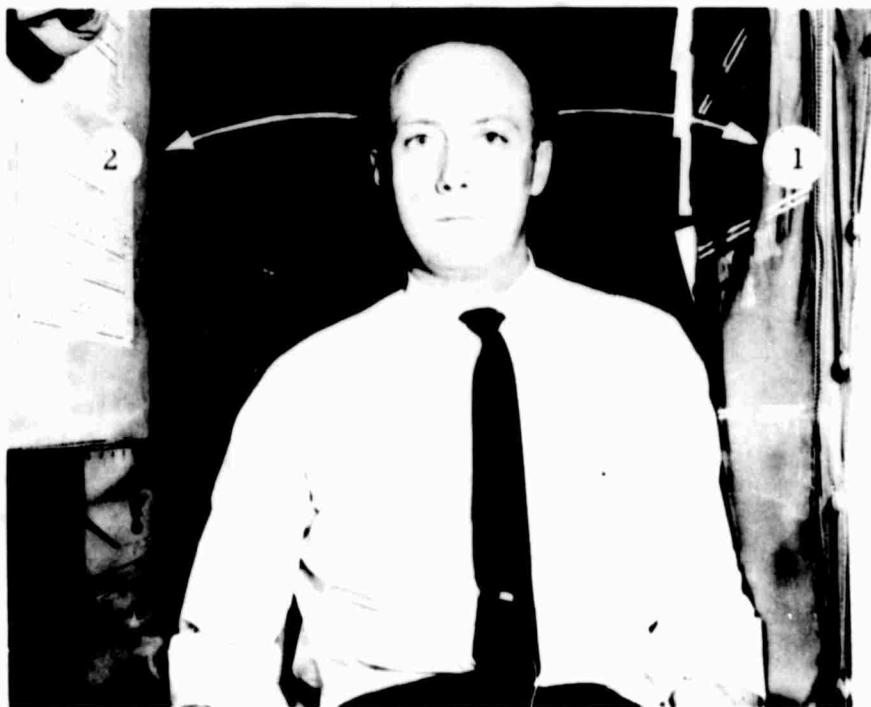
Figure 28. Crew chief/troop commander in normal seated position, restrained by safety belt, can strike structures (arrows). Structures behind curtain (1); right passageway bulkhead (2).

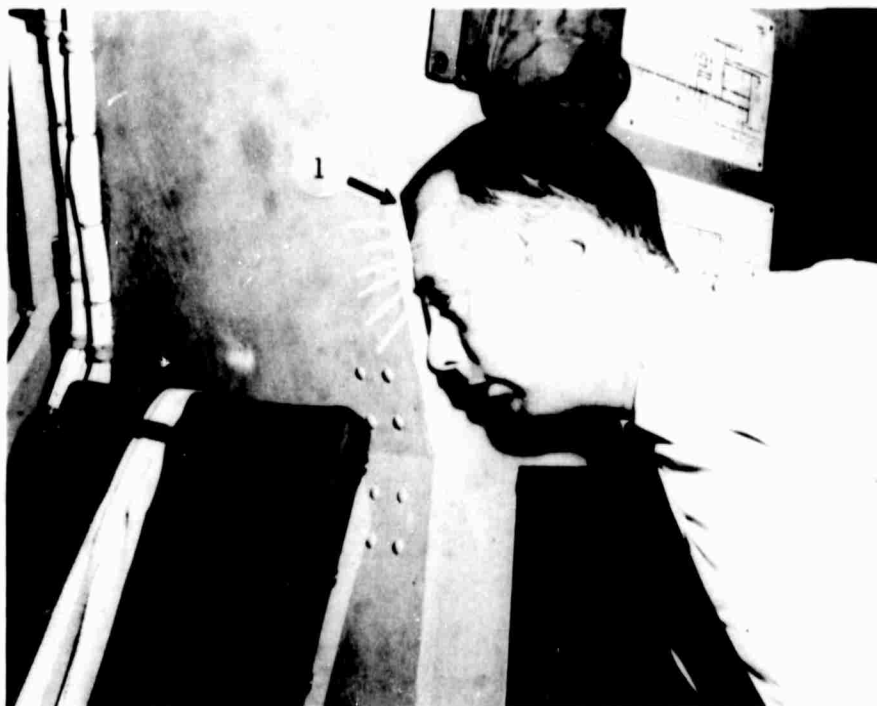
Figure 29. Crew chief/troop commander striking aft cockpit bulkhead flange (1).

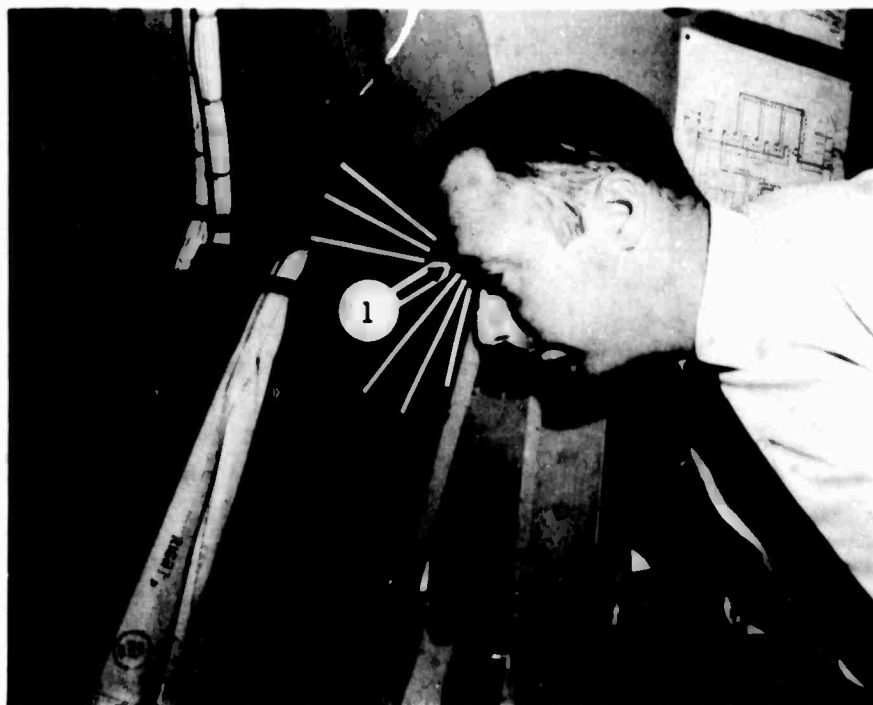
Figure 30. Crew chief/troop commander striking head against top left edge of pilot's seat (1). Restraint is by safety belt only.

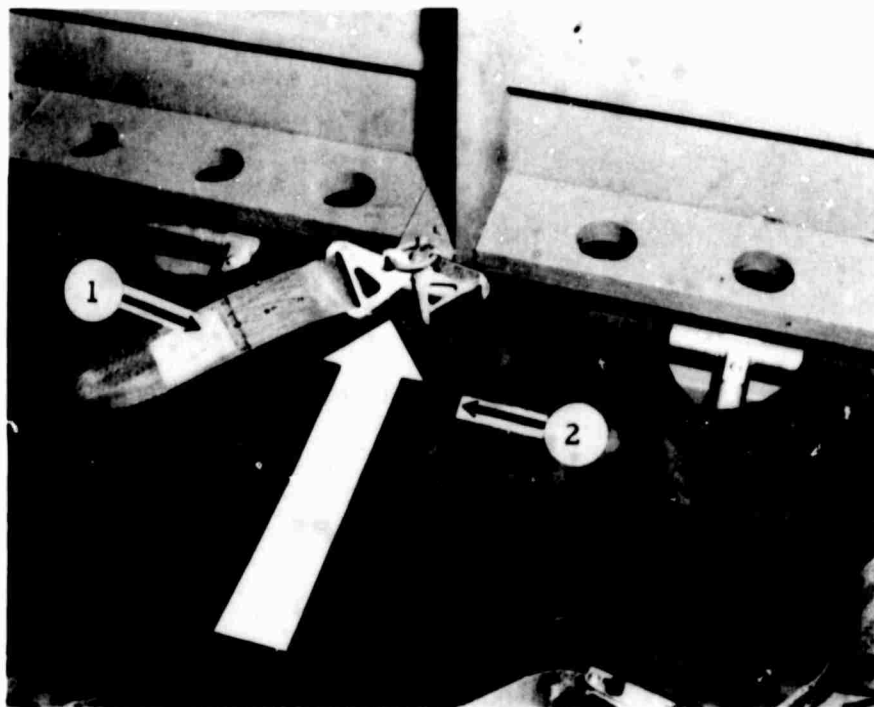
Figure 44. Safety belts (1 and 2).

Attention is invited to the manner in which the seat belts are attached to the "O" rings. Securing portions of two seat belts to a single attachment point (Figure 44) frequently results in failure of the anchorage due to the overload applied by two occupants. The seat belts, attached at points above the level of the seat pan, ride across the abdomen of the occupants (Figure 46).

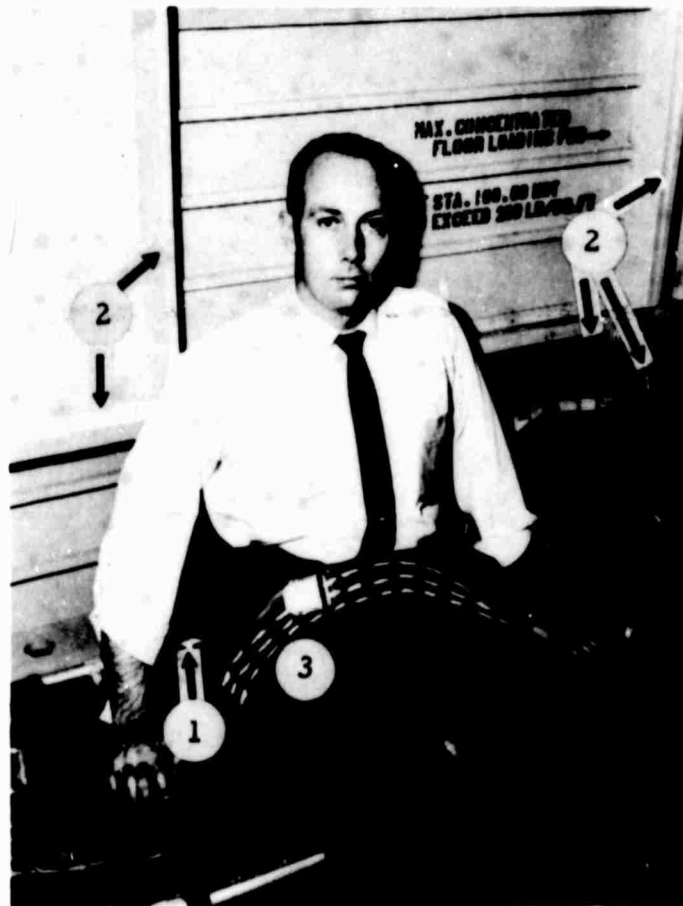
Figure 46. Occupant seated on troop seat - seat back removed. Safety belt anchorage (1); longitudinal and vertical structural fuselage members (2); preferred position of safety belt (3).

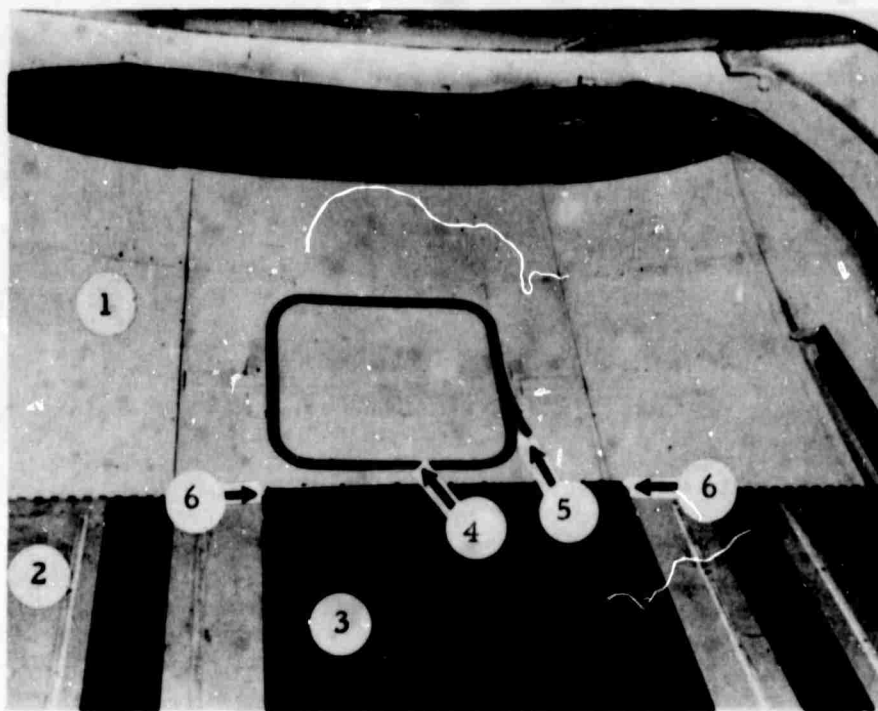
Figure 57. Closeup - Cargo door (1) in closed position; ramp (2); ramp extension (3); emergency exit (4); pull tab release (5); ramp extension hinge (6).

Note: Three ramp extensions will sometimes be utilized. There is no positive lock to prevent these extensions from swinging around to block the cargo door opening in the event the aircraft rolls onto its side.

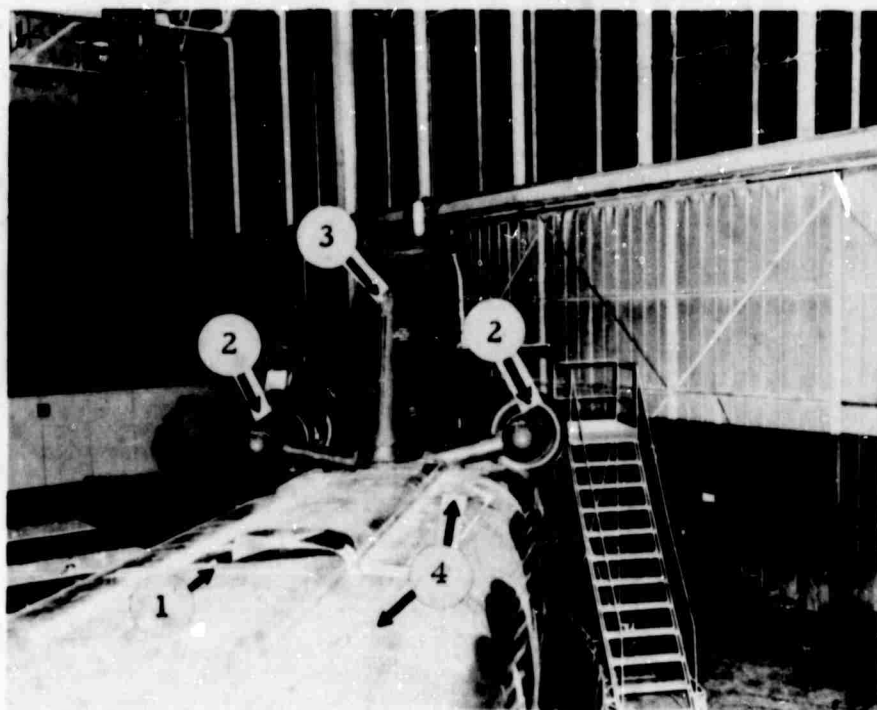
Figure 59. Top of cabin. Drive shaft tunnel (1); engines (2); aft pylon (3); possible area for overhead emergency exits (4).

Based upon the foregoing, the emergency exits provided in this aircraft are considered inadequate to accommodate the number of troops to be carried in the main cabin section. At least two more emergency exits should be provided on either side of the fuselage at the location of the window marked "cut here" and a window directly opposite on the left side. In addition, at least two emergency exits should be located in the roof structure, as illustrated in Figures 35 and 59. All other windows in the aircraft should be designed so they may be kicked out and the openings utilized as emergency exits.

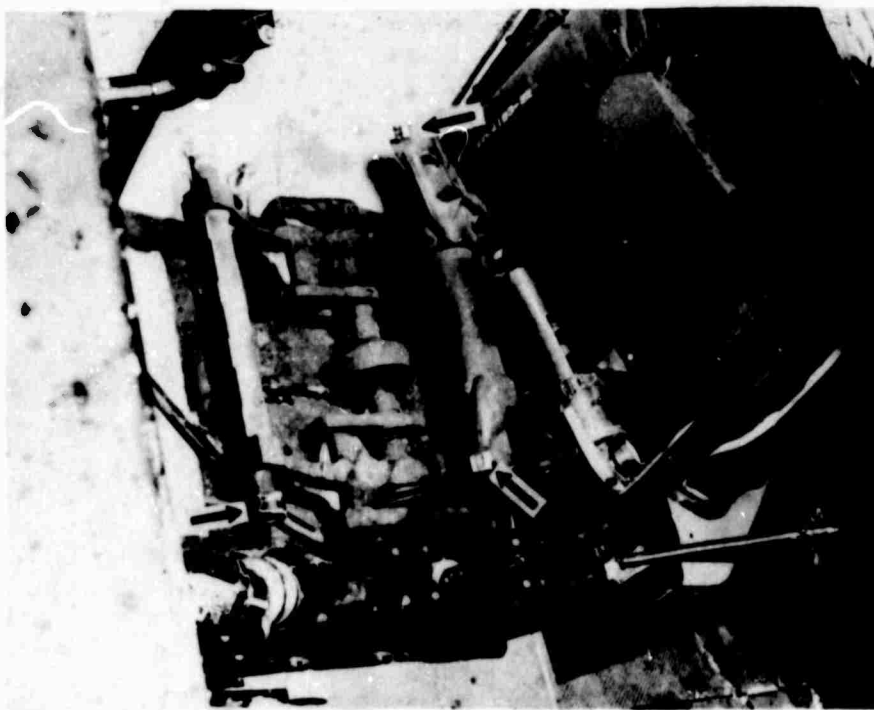
Figure 62. Illustration of pilot's seat failure in an H-21 accident (relatively moderate force - 8 to 12 G). When this seat failed, the occupant sustained abrasions and bruises of the left forehead, a fracture of the left arm and abrasions of the left arm and right leg.

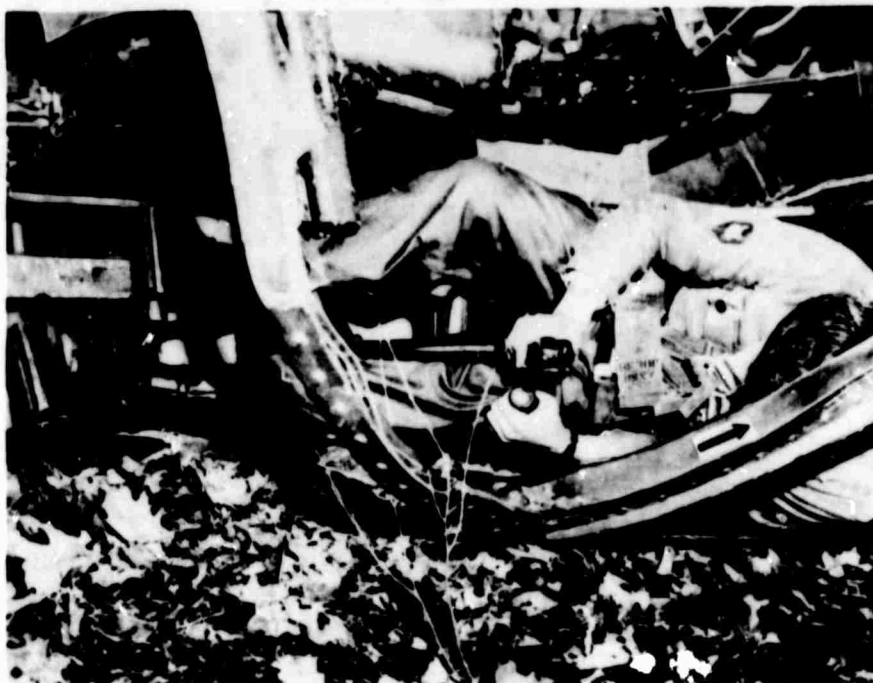
Figure 64. Posed picture to show where copilot struck his head on the vertical support member (window frame), receiving fatal intercranial injury when his seat broke under side load.

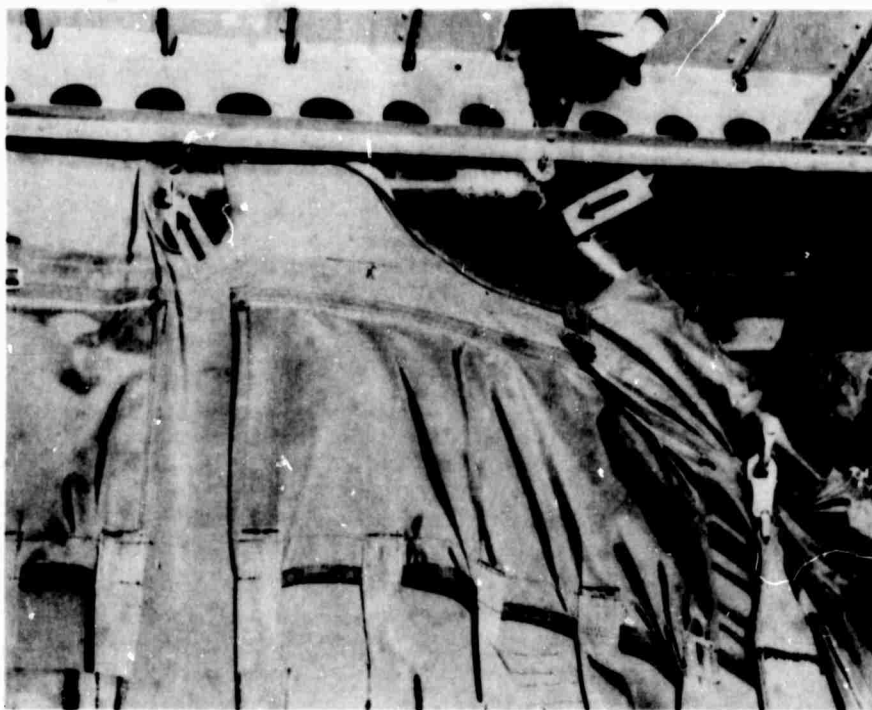
Figure 65. In this same H-21 accident, many troop seat failures occurred where tubular seat structure had been drilled for safety belt "D" ring mounting or pin attachment to the rail.

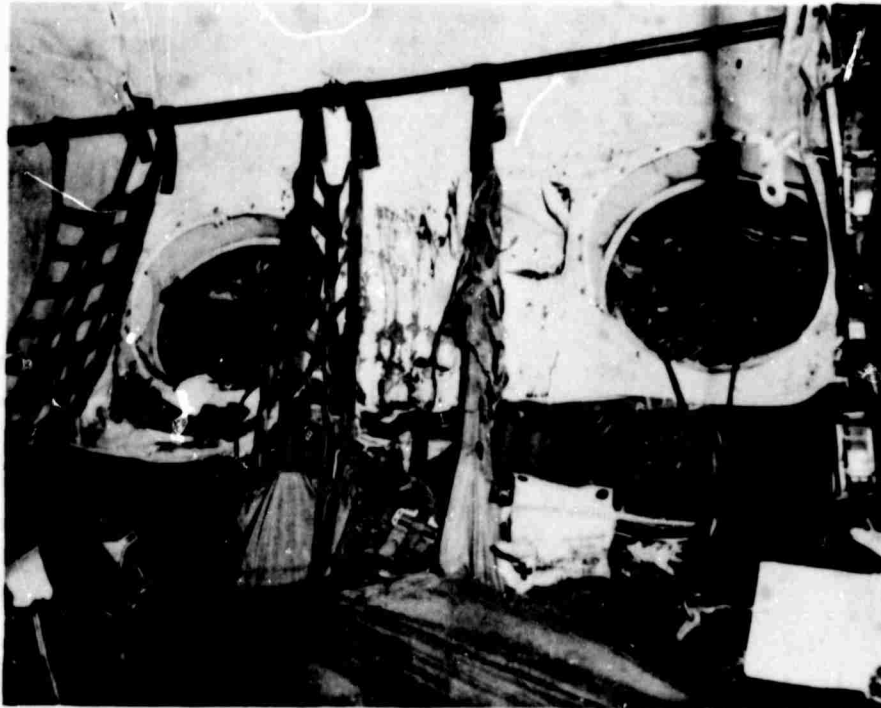
Figure 67. Another view of same accident showing troop seat damage.
